## An Analysis of Corrosion Products caused by Fretting/Wear-Accelerated Crevice Corrosion on Retrieved Co-Cr-Mo Implants

Matthew A. Di Prima<sup>1</sup>, Oleg Vesnovsky<sup>1</sup>, LD Timmie Topoleski<sup>1,2</sup>, Robert Hopper<sup>3</sup>, Charles A. Engh Jr.<sup>3</sup>, Paul Kovacs<sup>4</sup>,  
<sup>1</sup>US Food and Drug Administration, <sup>2</sup>University of Maryland Baltimore County, <sup>3</sup>Anderson Orthopedic Research Institute,  
<sup>4</sup>Electrochemistry/Biocompatibility Consultant

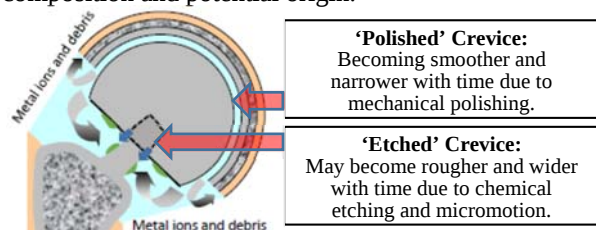
Figure 1. Different types of crevices in MoM implants.

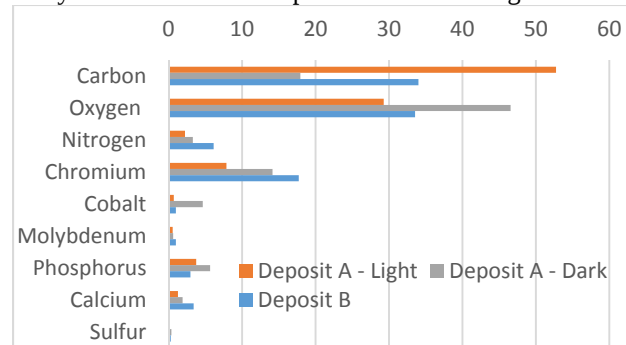
Figure 3. Atomic % of elements at 150 nm from the surface

For Deposit A, the main inorganic materials were  $\text{Cr}_2\text{O}_3 \cdot x(\text{CrPO}_4 \cdot 2\text{H}_2\text{O})$ , where  $x$  varied from 0.245 in the darker areas of the deposit to 0.807 in the lighter areas. This is in good agreement with the identification of an amorphous chromium orthophosphate hydrate-rich material in the vicinity of taper junctions in the early 1990s [2]. Additionally, it was also found that the lighter areas of the deposit had more calcium hydroxyapatite and the darker areas had more aged bone mineral. The environment seems to be basic, since a number of the cobalt and molybdenum compounds are hydroxides and oxyhydroxides. This is consistent with the higher pH values produced by the oxygen reduction processes at the cathodic sites. There was more cobalt in the darker areas of the deposit. At the greatest depth examined, the composition appeared to be characteristic of that at a metal-oxide interface. Overall, Deposit A appeared to be a mixture of coagulated corrosion product deposits, metallic wear debris, and particles of biological origin.

For Deposit B, the main inorganic material in the sub-surface was  $\text{Cr}_2\text{O}_3 \cdot 0.339(\text{CrPO}_4 \cdot 2\text{H}_2\text{O})$ . Lower concentrations of Mo and Co oxides – but more sulfur – were found. Cr and Mo carbides were also identified along with graphitic carbon. This finding is of particular interest since evidence for graphitic material in the tribological layer in metal-on-metal hip replacements retrieved from patients has been reported [6]. The graphitic carbon may have originated from that layer.
