## The Prevalence of a Column-Like Damage Pattern within CoCrMo Femoral Head Tapers

Deborah J. Hall, Robert M. Urban, Stephanie M. McCarthy, Jennifer L. Wright, Joshua J. Jacobs, Robin Pourzal  
Department of Orthopedic Surgery, Rush University Medical Center, Chicago, IL

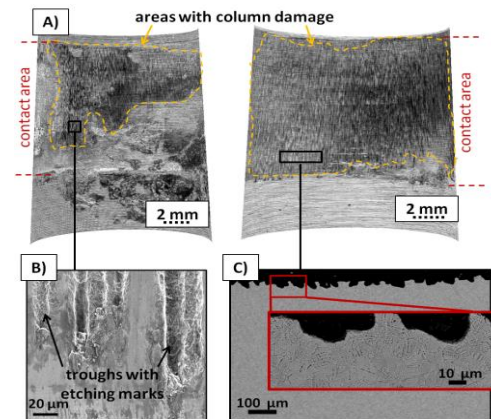
3D profiler measurements showed the majority of the troughs stretched from the proximal end to the middle of the taper, and only in some cases, troughs reached all the way to the distal end of the contact area (Fig 1A). The column damage troughs exhibited no material pile-up on the sides, had an etched surface appearance (Fig 1B), and were often filled with organic residue. Imaging of a cross-section sample of column damage showed an oddly shaped trough profile with a depth of 20-40µm (Fig 1C). The surrounding microstructure showed little evidence of

Figure 1. A) Images of two head taper replicas with partial (left) and full (right) coverage of column damage. B) SEM image of etched surface within troughs. C) Cross section image of an area with column damage.

mechanical damage. On 3 of the 15 heads analyzed by SEM, there was evidence of preserved cells adherent to areas with column damage, but no evidence of cells adhering to corresponding stem tapers made from either Ti-alloy or cast CoCrMo alloy. The cells appeared similar to macrophages in morphology and size. Their presence was associated with an etching trail which exposed grain and twin boundaries. Cells were mainly located within the troughs, and appeared migrating from proximal to distal.
